# A PQ Case Study

CS 36 HOSP 14

A Case Study OF Harmonics Mitigation in a Hospital and its Benefits

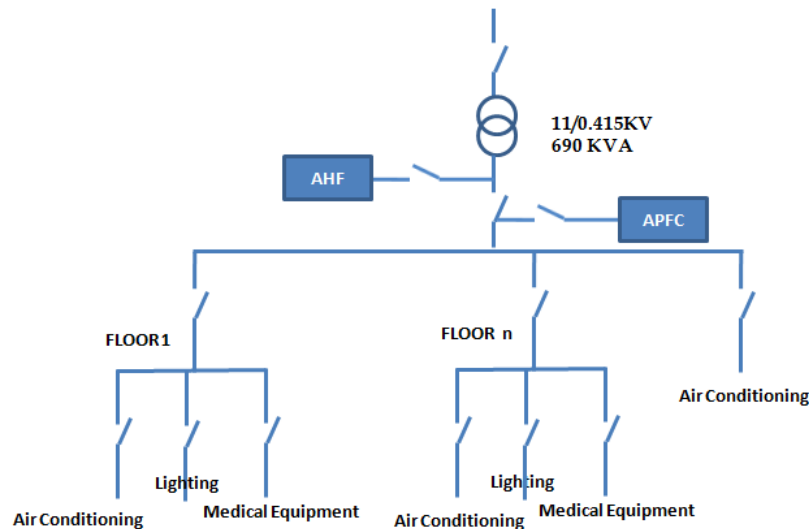
Fig.no.1 Single line diagram of facility

Single line diagram below shows distribution system of the facility. The facility has installed an active harmonic filter of 125 Ampere capacity at the PCC level to reduce harmonics along with APFC panel of 650KVAR. From PCC, number of panels distributes power to each floor where it is distributed further. On each floor, typical distribution of load consists of lighting, split air conditioners and medical equipment.

Problem faced in the ultra sound machine for disturbance on the screen was still present even after installation of active harmonic filter. In order to find possible reason and solution to the problem, some more detailed measurements were carried out. As indicated in the above single line diagram, active harmonic filter was installed at the point of common coupling.

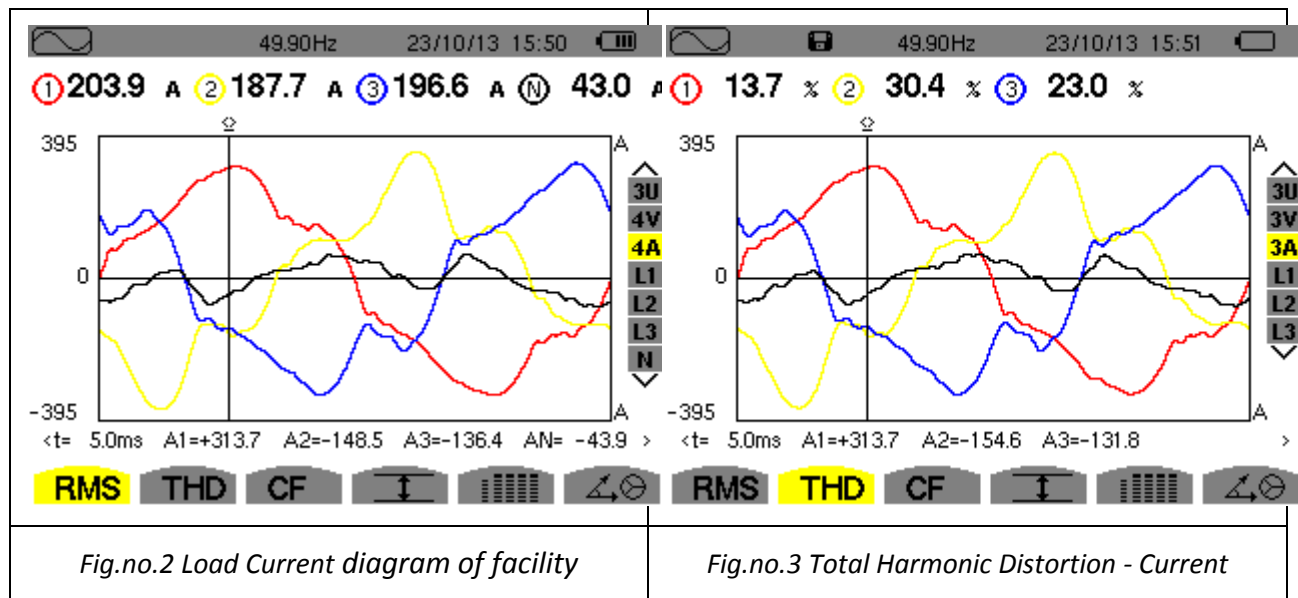
Fig.no.2 Load Current diagram of facility

**Figure 2** shows load current during normal operating hours. It can be seen from the snapshot that all phases of the wave form are distorted and are not close to a perfect sinusoidal wave form. Neutral current is 43 amperes which is quite high. Presence of harmonic current in the system distorts fundamental current wave forms. One of the reasons for high neutral current could be triplen harmonics Measurements for harmonics are shown in next section.

**Figure 3** shows a snap shot for the total current harmonic distortion in the system. For each phase total current harmonic distortion is different. In R phase, THDi is 13.7%, Y phase 30.4% and in B phase THDi is 23%. Variation in the difference of total current harmonic for the phases is due to presence of lighting load that is connected on Y phase. Some single phase medical equipment are also connected in the same phase Presence of these harmonic current distort fundamental wave form and also peak value of the wave form is increased.

Figure 5 shows when harmonic filter was in line, distortion level of the wave forms was much lower as compared to the condition when harmonic filter was switched off. The waveform was close to sinusoidal waveform as compared to waveform in figure number 2. Also current in the neutral is significantly reduced from 43 amperes to 32.6 amperes.

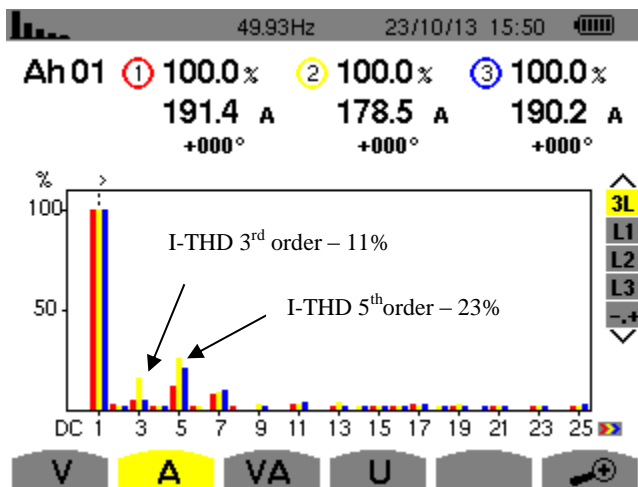
Fig.no.4 –Order of current harmonics

From the figure4 it can be seen that 3<sup>rd</sup> / 5<sup>th</sup> and 7<sup>th</sup> order of harmonics are predominant in nature where as harmonics were present up to 25<sup>th</sup> order and above. 3<sup>rd</sup> order harmonics were found to be up to 11% where as 5<sup>th</sup> order harmonics were up to 23%. High neutral current can be attributed to presence of triplen harmonics which

are of the order 3<sup>rd</sup> , 9<sup>th</sup> and 15<sup>th</sup>. 3<sup>rd</sup> harmonic present in Y phase are up to 25 amperes. RMS value of 5th order harmonics was found to be up to 44 amperes.

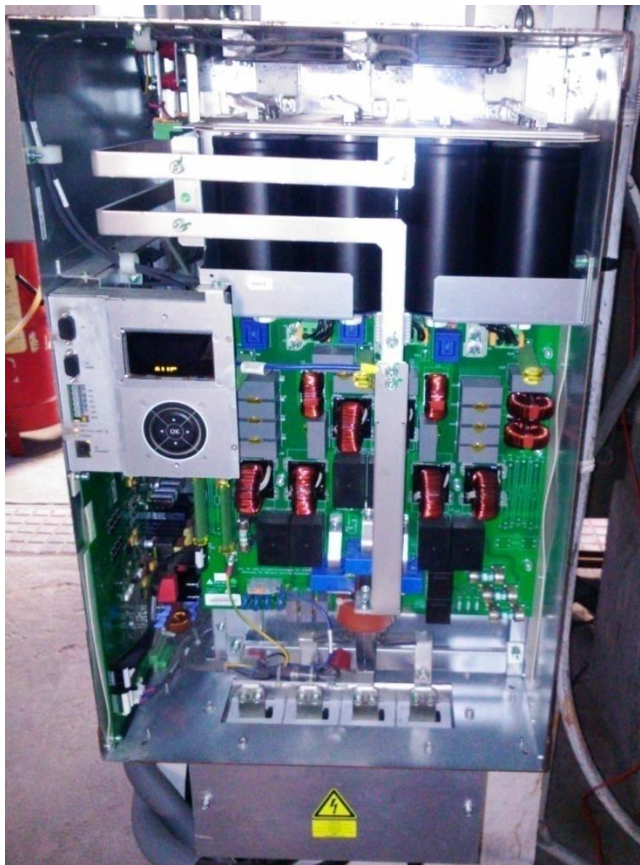
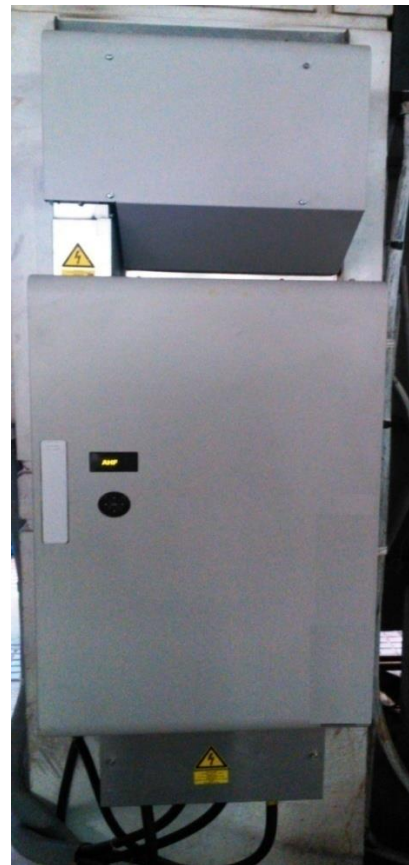
Installed Harmonic Filter at the Facility

From the above measurements, it was evident that high percentages of harmonics were present in the system. In order to mitigate harmonics, hospital management decided to install 120 ampere active harmonic filter recommended by PQ auditor.

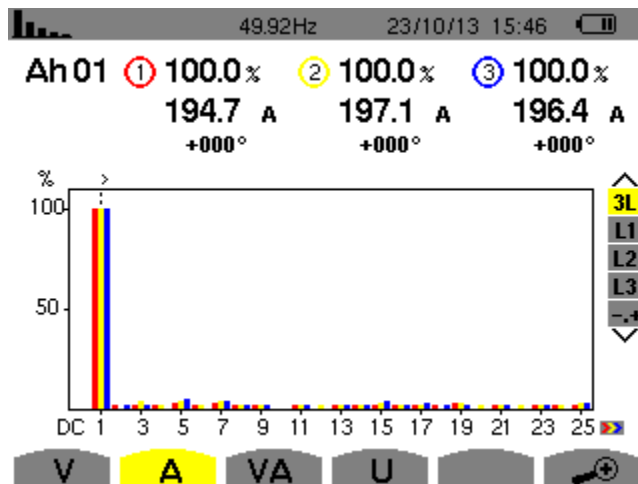
Fig.no.6 –Order of current harmonics

From the figure 6 it can be seen that 3<sup>rd</sup> / 5<sup>th</sup> and 7<sup>th</sup> order of harmonics are reduced to considerable extent. Reduction in triplen harmonics also reduced current flowing in the neutral of the system. After installation of harmonic filter 3<sup>rd</sup>, 5<sup>th</sup>, and 7<sup>th</sup> order of harmonics are reduced to 2.2%, 3.2% and 2.1% respectively.

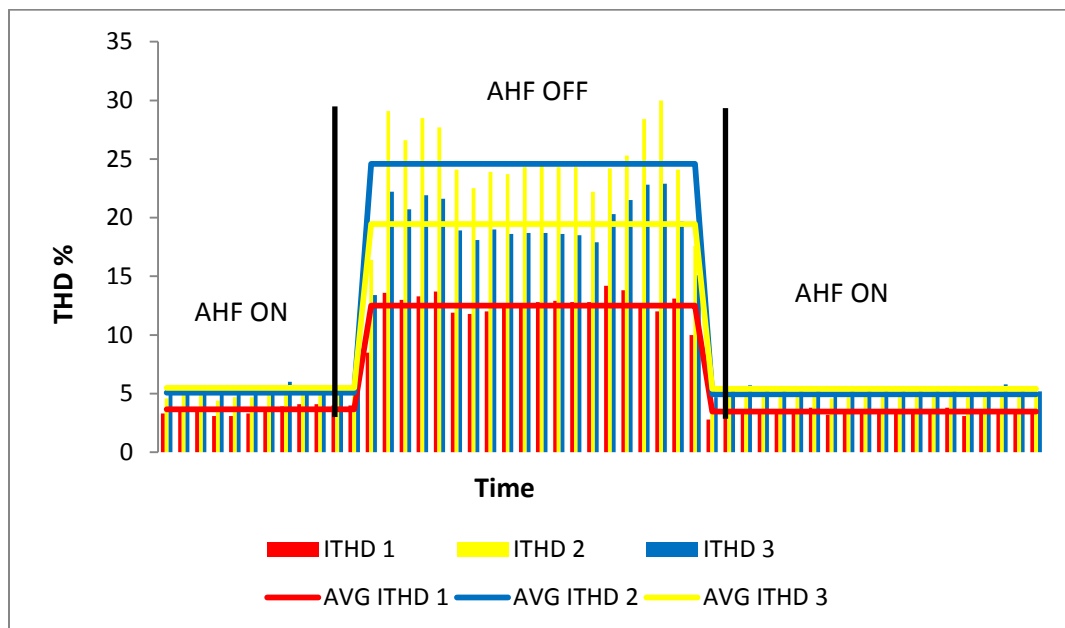
Graph-1 Total Current Harmonic Distortion with and without AHF

Graph-1 shows total harmonic distortion in percentage against time. It can be seen from above graph that when active harmonic filter was switched ON, there is drastic reduction in total

harmonic distortion in current. When active harmonic filter is OFF, THD percentage is up to 25% but when active harmonic filter is switched ON, THD percentage is reduced to below 5%.

From the above measurements, it can be seen that by installing active harmonic filter, magnitude of harmonic distortion is reduced to considerable extent within the limits prescribed by IEEE and as desired by the hospital. The harmonics that are being fed to the upstream of the grid are within IEEE limits. As of now there is no penalty by the distribution company on the harmonic distortion, but in future if levied then the harmonics are within limits. This would enable customer to avoid any penalty imposed due to distortion in future by distribution company.

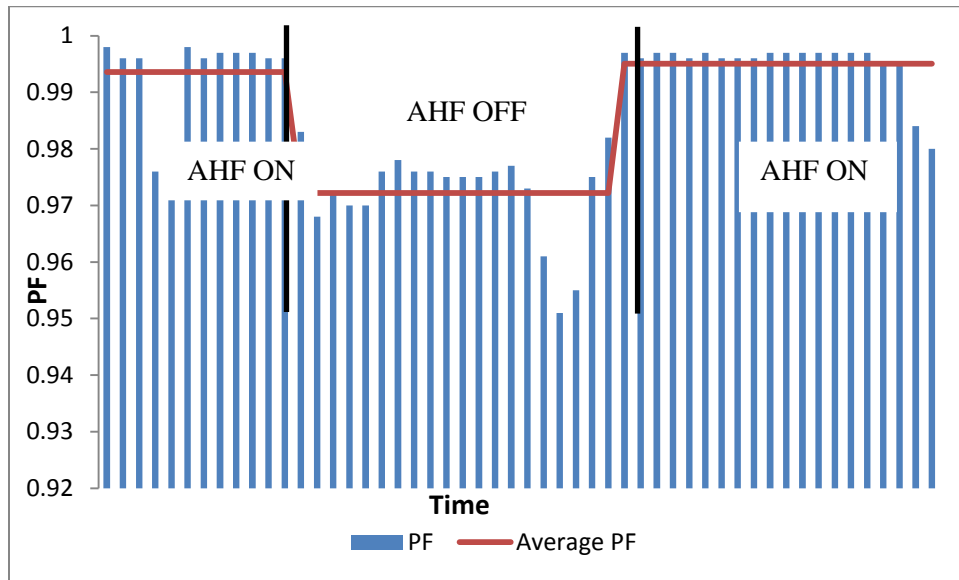
Graph-2 Power Factor With and without AHF

Graph -2 below shows effect of harmonic filter on power factor. In the absence of harmonic filter power factor was close to 0.97 and when harmonic filter was switched on power factor improved to 0.995 and above. A major concern arising from the use of capacitors in a power system is the possibility of system resonance. This effect imposes voltages and currents that are considerably higher than would be the case without resonance. The reactance of a capacitor bank decreases with frequency, and the bank, therefore, acts as a sink for higher harmonic currents. This effect increases the heating and dielectric stresses. The result of the increased heating and voltage stress brought about by harmonics is a shortened capacitor life. One of the indicators of resonance is humming noise coming out of capacitor bank. This phenomenon was also observed at the facility. When harmonic filter were switched off, it was observed that there was a continuous humming noise coming from capacitor bank. When harmonic filter was switched on there was no humming noise coming from the capacitor bank.

By reducing current harmonics, power factor is improved and humming noise is eliminated from the capacitor bank. Also it is reported that capacitor bank failure is heavily reduced.

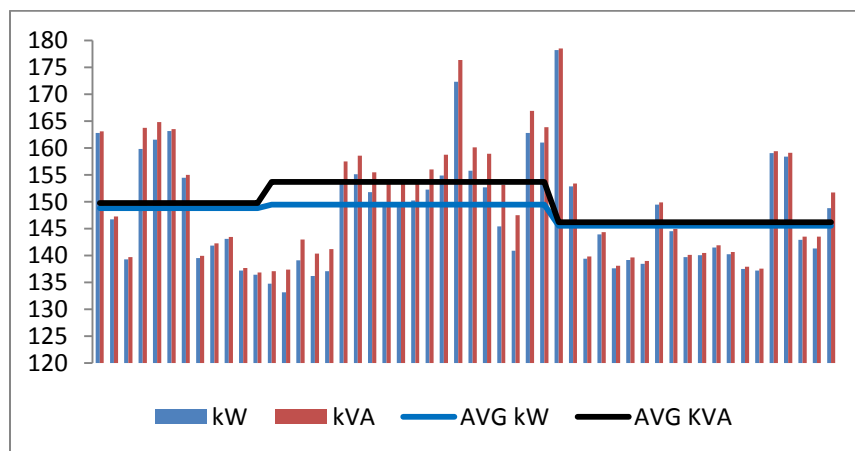
Graph-3 kW and kVA with and without AHF

Most of the utility boards are now opting for kVAh billing instead of kWh billing. In kVAh billing, harmonics distortion makes a great impact as compared with kWh billing. Graph-3 shows difference in kW and kVA when harmonic filter was switched ON and OFF.

From the graph it can be seen that in the absence of harmonic filter, average values for both kW and kVA has increased. When active harmonic filter was switched off, average value for load was 149.45kW. As soon as harmonic filter was switched ON, average load came down to 145.5kW. For kVA, average value dropped down to 146kVA from 153.6kVA when harmonic filter was switched ON. The average difference in kW was 3.94kW whereas average difference in kVA was 7.5kVA.

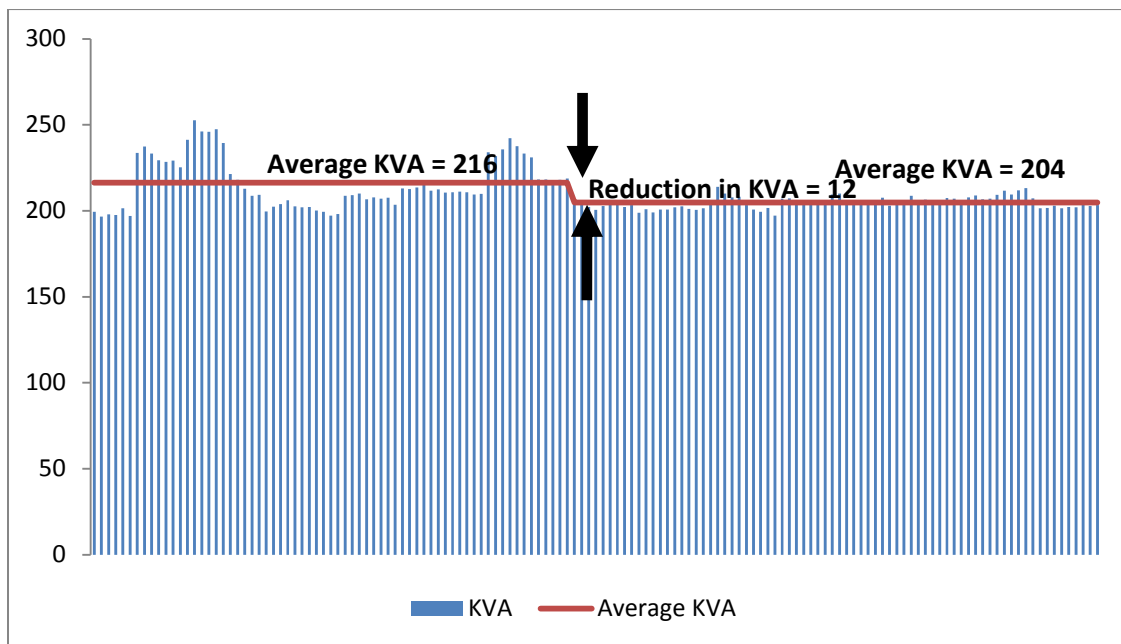
Graph-5 kVA on HT side of the transformer

Graph-5 below shows reduction in kVA in the presence of harmonic filter on HT side of the transformer. In the absence of harmonic filter average kVA value was 216 kVA. When harmonic filter was switched ON average recorded kVA value was 204 kVA. In the presence of active harmonic filter demand is reduced by 12 kVA. With energy cost of INR 7.5 per kVAh, annual cost saving by installing harmonic filter at the facility is around 788,400.00 Indian rupees per annum.

Average reduction in kVA	-	12 kVA
Annual operating hours	-	8760 hours
Unit energy cost	-	INR 7.5 per kVAh
Annual saving	-	INR 788,400.00
Investment	-	INR 750,000.00
Payback	-	1 year

By installing active harmonic filter hospital management gained substantial monetary benefit in terms of reduced electricity charges. In other words it conserved energy. With an investment of around INR 750,000.00, energy charges are reduced by INR 788,400.00. Simple payback period for installation of active harmonic filter was just under one year.

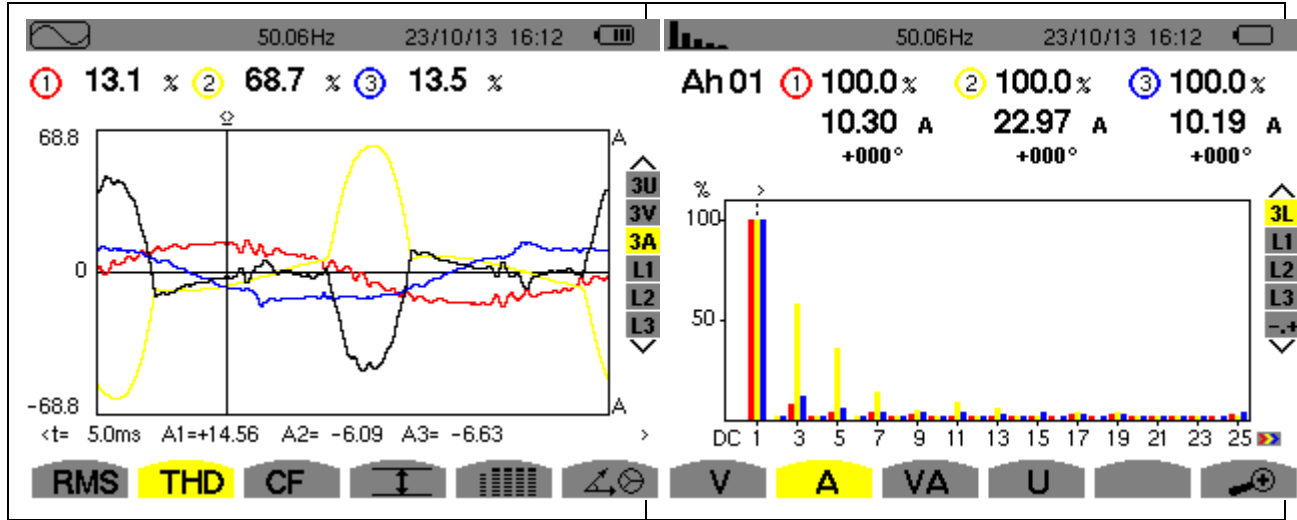
Figure – 7 Total Harmonic Distortion at MCC

When measurements were taken at the particular MCC feeding the floor on which ultra sound machine is placed, it was found that harmonic content were quite high. Although a harmonic filter is installed, but this filter is only filtering out harmonics from going to the grid. However harmonic current generated by different load are still present in the system and needs to be filtered out from re-circulating in the system. Following graphs shows content of harmonic distortion at the feeder.

From the above two figures it can be seen that total harmonic distortion in the Y phase is more than 50%. Also 3<sup>rd</sup> and 5<sup>th</sup> orders were predominant harmonics present in the system.

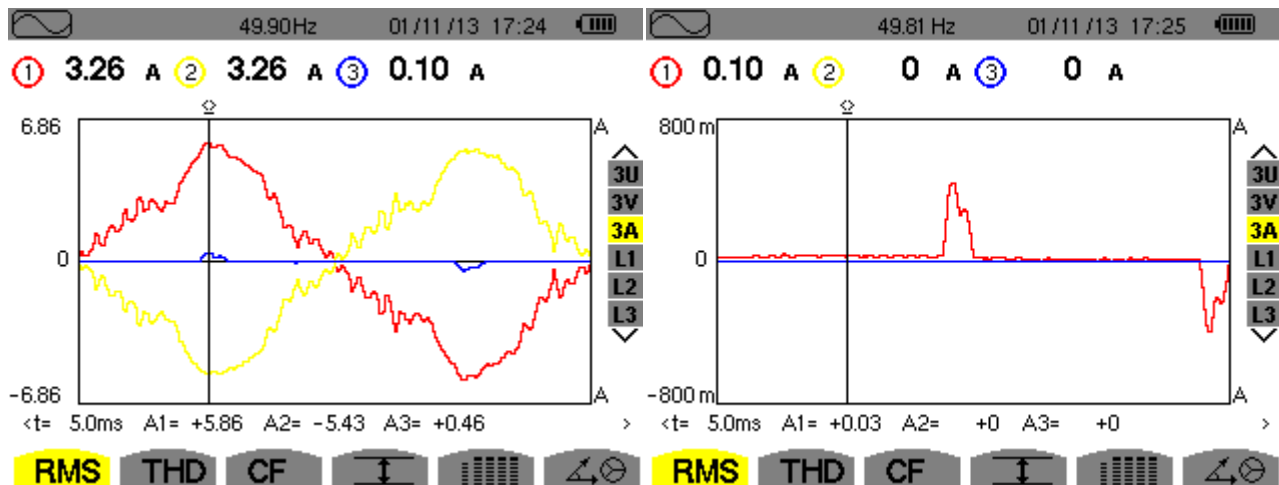
Figure – 9 Current in phase, neutral and leakage

Measurements were also carried out at the supply of ultra sound machine. Figure-9 shows current in phase (Red colour), neutral (yellow colour) and leakage current (blue). Figure 10 shows current in neutral when switch was switched off but plug was still in the socket, there was flow of current in neutral even when supply was switched off.

As there was no protection or mitigation measure adopted to filter out harmonics generated by different loads, some of these harmonics were flowing in the system and rest were going in the upstream of the network to the grid. It is recommended to install an isolation transformer at the incomer of ultra sound machine. Isolation transformer will ensure that electrical noise will not be transferred to the ultrasound machine by creating a floating neutral.
